XC27x5X Derivatives

16/32-Bit Single-Chip Microcontroller
with 32-Bit Performance

Errata Sheet

V1.5 2013-02

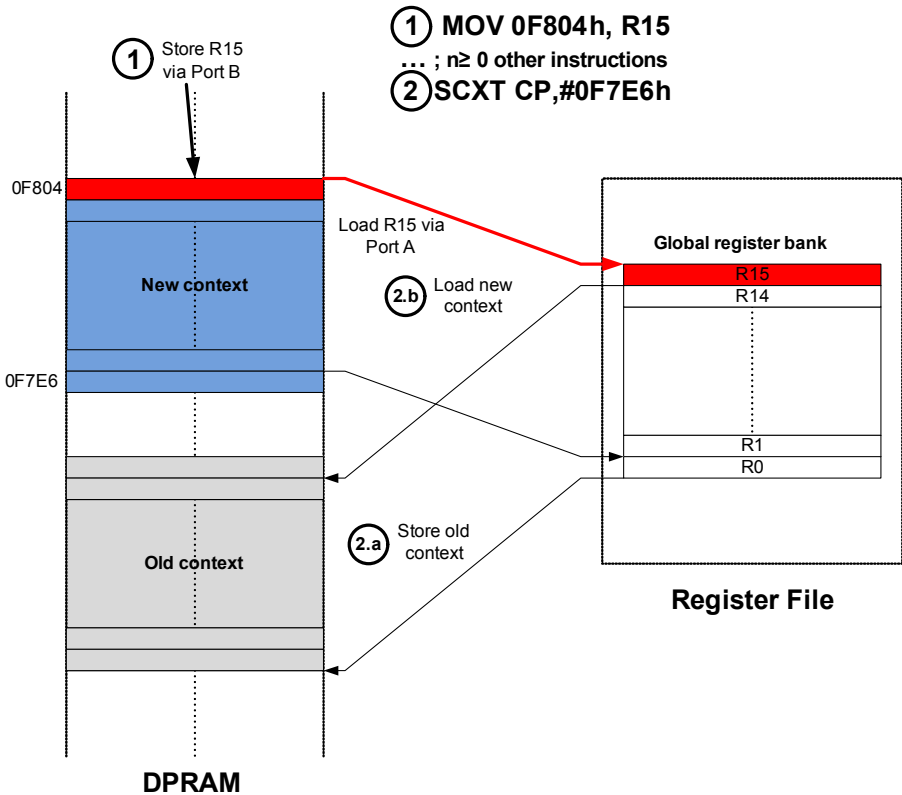
Figure 1 Context Switch with Pointer Passing in R15

Under special conditions, undefined data may be read from up to two word locations L_1 , L_2 in the DPRAM (address range $F600_H .. FDFH_H$).

The problem (affecting L_1 and/or L_2) is due to a redundancy circuit that may not be properly disabled during the internal power-up reset sequence.

This scenario may typically occur at the beginning of interrupt routines when a GPR (e.g. R15 used as user stack pointer) is saved into the new GPR context in DPRAM, as shown in the following **Figure 1**.

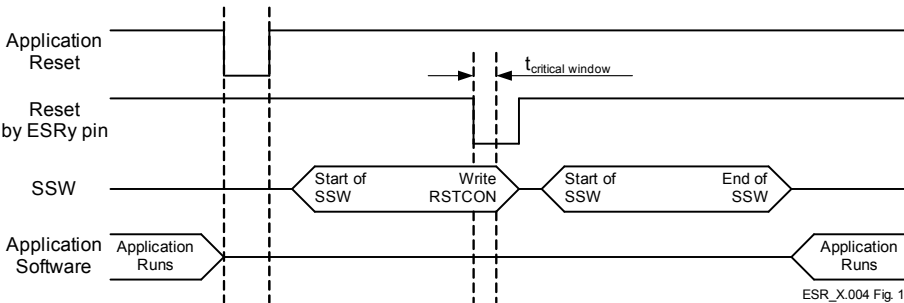
Figure 2 Critical application reset sequence

`SCU_RSTCONx` registers are reset only by Power-On, but they may be wrongly affected after a second application reset requested by an ESRy pin. This may lead to the `SCU_RSTCONx` register values being set to zero, which could unexpectedly disable reset sources within the user application. The conditions which lead to this behavior are:

1. First, an application reset by SW (software), CPU (Central Processing Unit), MP (Memory), WDT (Watchdog Timer) or ESRy (External Service Request y) occurs.
2. Following this, an application reset on an ESRy pin occurs.
3. If the above mentioned ESRy reset occurs during a critical time window of the SSW (startup software), then it's possible that the application will operate with the wrong `SCU_RSTCONx` register value. The critical time window occurs when the SSW is writing the `SCU_RSTCONx` registers, and at the same time, the ESRy reset request is processed by the reset circuitry. The width of this critical window $f_{\text{critical window}}$ is less than 13 cycles.

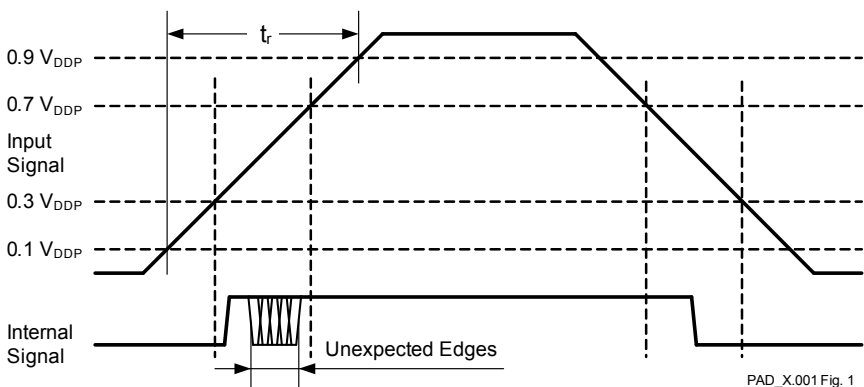
Figure 3 Example for a Slow Input Signal

The digital input- and I/O-pins are designed using Schmitt trigger input structures with hysteresis. Even with this structure, it is possible that very slow rising edges may generate spikes, resulting in unexpected additional edges at the input signal.

The next picture **Figure 3** is an example for a slow input signal, with spikes shown on the slow rising input signal.

The first rising edge in **Figure 3** of the internal signal is always valid. The edges which are marked with “Unexpected Edges” must be ignored.

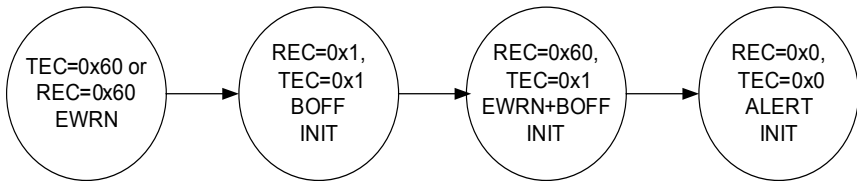
Figure 7 Alert Interrupt Behavior in case of Bus-Off

The MultiCAN module shows the following behavior in case of a bus-off status:

When the threshold for error warning (EWRN) is reached (default value of Error Warning Level EWRN = 0x60), then the EWRN interrupt is issued. The bus-off (BOFF) status is reached if $TEC > 255$ according to CAN specification, changing the MultiCAN module with REC and TEC to the same value 0x1, setting the INIT bit to 1_B, and issuing the BOFF interrupt. The bus-off recovery phase starts automatically. Every time an idle time is seen, REC is incremented. If REC = 0x60, a combined status EWRN+BOFF is reached. The corresponding interrupt can also be seen as a pre-warning interrupt, that the bus-off recovery phase will be finished soon. When the bus-off recovery phase has finished (128 times idle time have been seen on the bus), EWRN and BOFF are cleared, the ALERT interrupt bit is set and the INIT bit is still set.

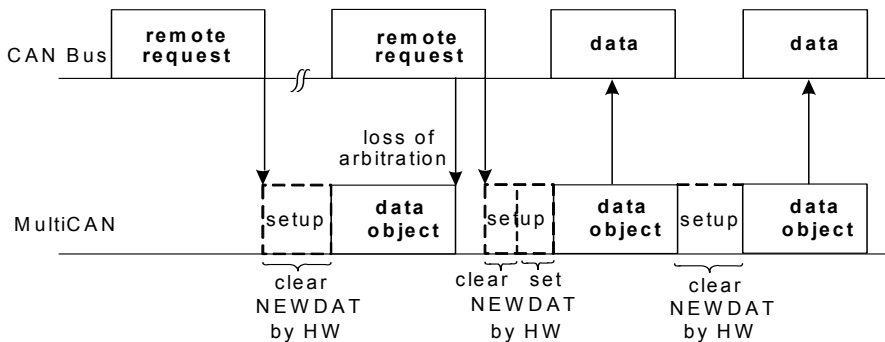
Figure 8 Loss of Arbitration

When the appropriate message object (data frame) triggered by the first remote frame wins the arbitration, it will be sent out and NEWDAT is not reset. This leads to an additional data frame, that will be sent by this message object (clearing NEWDAT).

There will, however, not be more data frames than there are corresponding remote requests.
